YOUR ONESURVEY  
**HOME REPORT**

Fox Covert  
Kaimflat  
Kelso  
TD5 7QN

# SINGLE SURVEY

# Single Survey

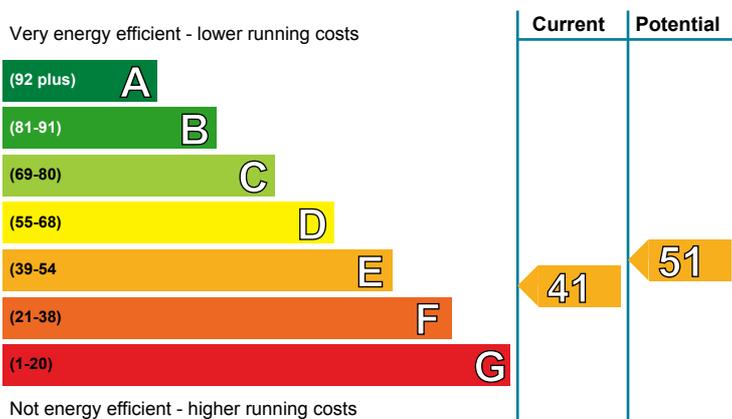
## Energy Efficiency Rating

This graph shows the current efficiency of your home, taking into account both energy efficiency and fuel costs. The higher this rating, the lower your fuel bills are likely to be.

Your current rating is **band E (41)**. The average rating for EPCs in Scotland is **band D (61)**.

The potential rating shows the effect of undertaking all of the improvement measures listed within your recommendations report.

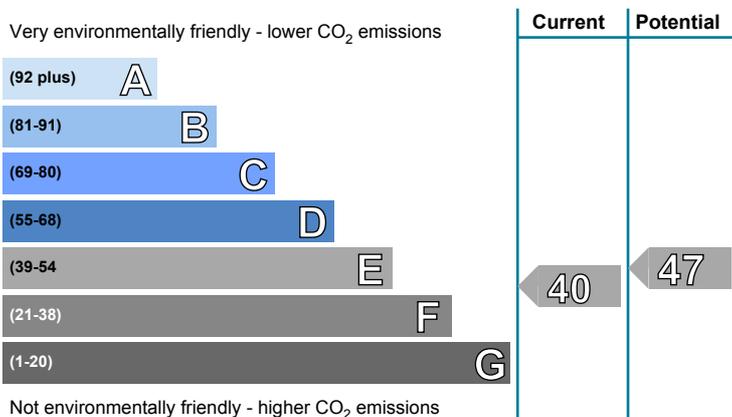
## Environmental Impact (CO<sub>2</sub>) Rating

This graph shows the effect of your home on the environment in terms of carbon dioxide (CO<sub>2</sub>) emissions. The higher the rating, the less impact it has on the environment.
